Offshore Rehabilitation of Steel Flow Line Pulling 2 3/8" Thermoflex Through Multiple Diameters of Steel

Background: A company in Rockport Texas had an existing oil/brine/gas flow line between an offshore platform in the gulf and an on shore facility. The existing steel line approximately 14,000ft in length was comprised of four inch, six inch and eight inch steel pipe. The line had multiple leaks, and was repaired regularly. Because the well only produced 100bbl/day of fluid and 60MCF/day of gas, a 2 3/8" Thermoflex was determined to be suitable to pull through the existing line to create a new corrosion resistant line. Campbell Energy Services was the general contractor for the project.

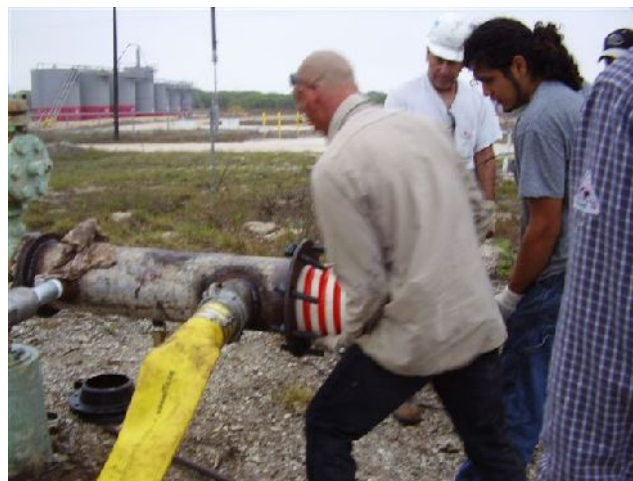
Procedure: The line had to have a rope pulled through the 14,000ft in order to pull the pipe back through the existing steel line. The task was difficult because the pig blown through the line did get stuck from a few transitions from eight inch steel to four inch steel. These short length reductions in diameters were cut out and the pig continued to flow through the line. The line was also flooded with water to reduce the pull force required to pull the line. This force can be up to ninety percent less than pulling through a dry line. The rope was designed for a 20,000lb pulling capacity.

Setting the Pig in Place

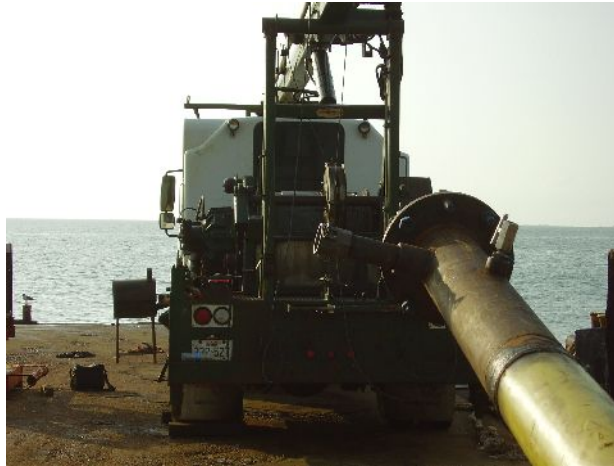
Figure 2 Winch Truck

Once the roped was pigged through the line, the pipe was staged on shore and pulled with a winch truck to the platform. It is much more convenient moving pipe around on shore versus on a barge. A pulling cone was attached to the lead and the winch below started to pull the pipe back. See figure 2 and 3.

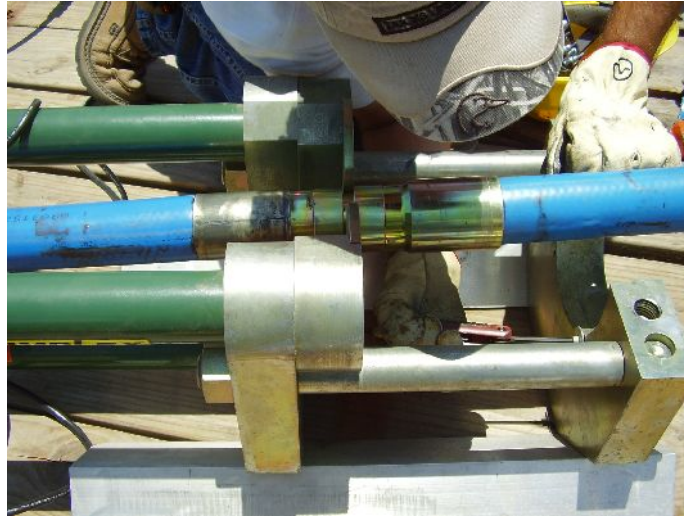
Figure 4: Splice Coupling Assembly

After the pipe was completely unspooled a second spool was set in place and a splice coupling was attached to the end of the first spools length and the beginning of the second. The splice coupling is a joint less system that is 1.5X the strength of the pipe. See figure 4. The first 9,000ft of pipe was pulled through in 3 hours with a maximum pull force of 1,800lbs.

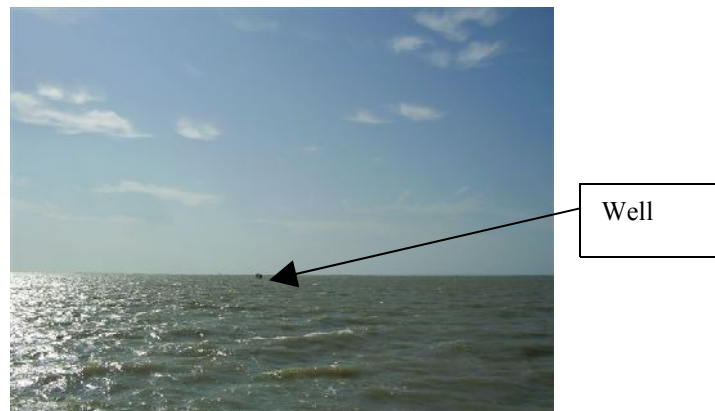
The line was then hydro tested at 1.5X MAOP of 500PSI (750Test Pressure)

Wellhead from Shore
