January 2009

Middle East Offshore Pipeline Rehab

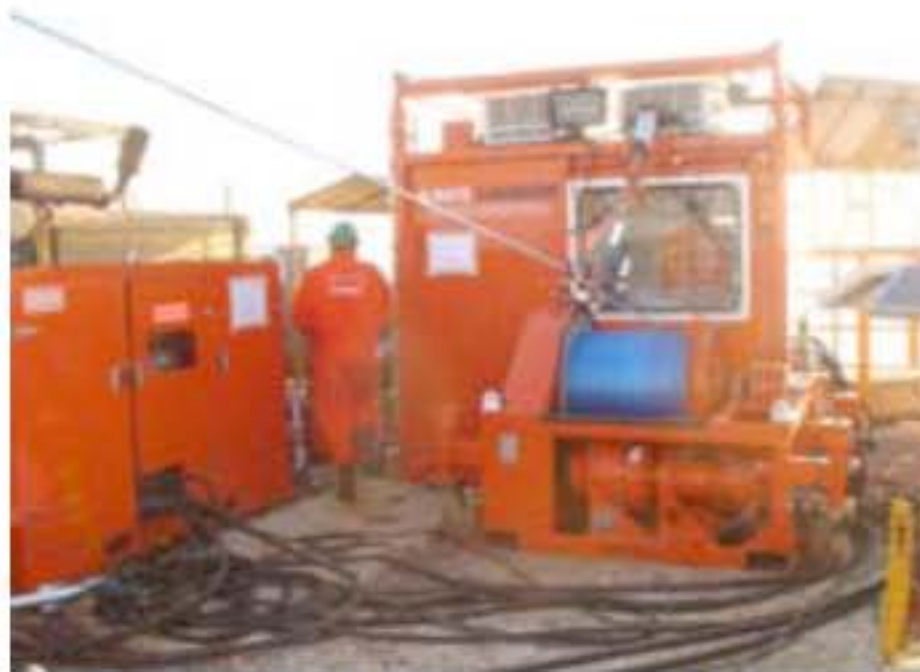
Figure 1: Pulling Rope and Winch

The existing high pressure steel pipe was pigged to assure that there were no restrictions along the line. A braided rope wound on a winch was then attached to a pig and pulled through the existing pipeline. The rope was rated for 38,000lbs See figure one.

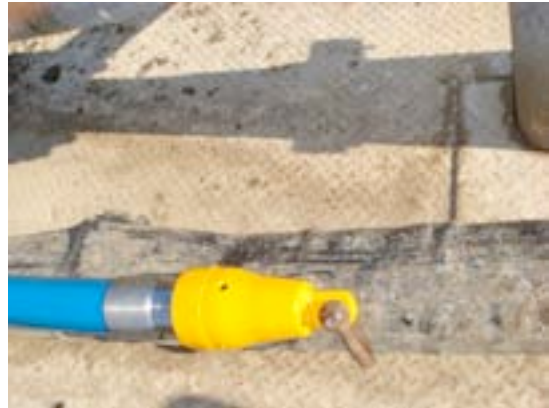
Figure 3: Pulling Cone

Once the roped is pigged through the existing pipeline, the spools of pipe (see figure 2) were set into position, a termination coupling was installed on the end of the pipe and a pulling cone screwed on to the termination coupling for pulling (See figure 3)

The pulling cone was attached to the rope and the winch pulled the pipe off an A-frame at a rate of 10 to 20 feet per minute (3 to 6 meters per minute) The maximum length of tubing that could fit on a 10ft spool is 1,800ft. When one spool was complete, the pulling was stopped a splice coupling installed to connect the next spool. (See figure 4) There was radio contact between platforms to make sure the winch operator knew when to stop and start the pulling and to make sure the load does not exceed 9,000lbs of pull strength. Thermoflex tubing can be designed with various pull strength requirements depending upon the pull length and bends in the line. Please consult Polyflow to review the project to determine the correct pull force requirements.

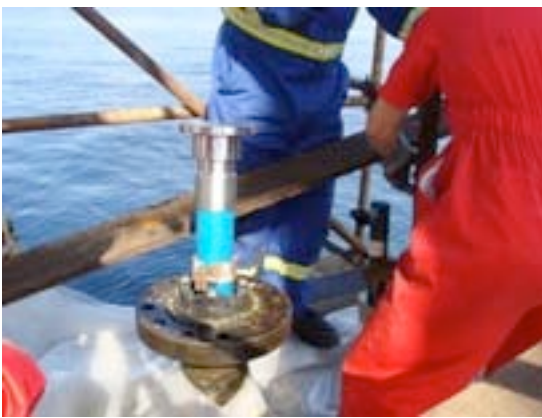
Figure 6: Flange Termination

Once the entire tubing length was pulled through the existing pipe, a flange termination was coupled on the tubing and the line was pressure tested at 1,700PSI with water. The line was then pigged of water and put into service. The entire project took three and a half days.
